# I. EXTERIOR MATERIALS

## A. CONCRETE

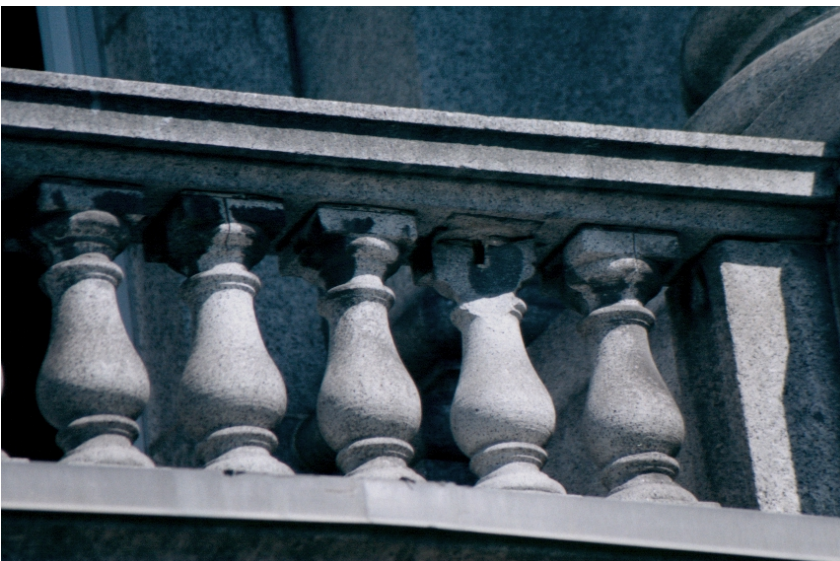
The measured as-built exterior elevation drawings prepared for this report show each stone in the building, and the exterior elements surveys indicate the presence of cracking, staining, missing mortar and other masonry problems. The exterior survey sheets, including photos, are found in the Appendix of this report.

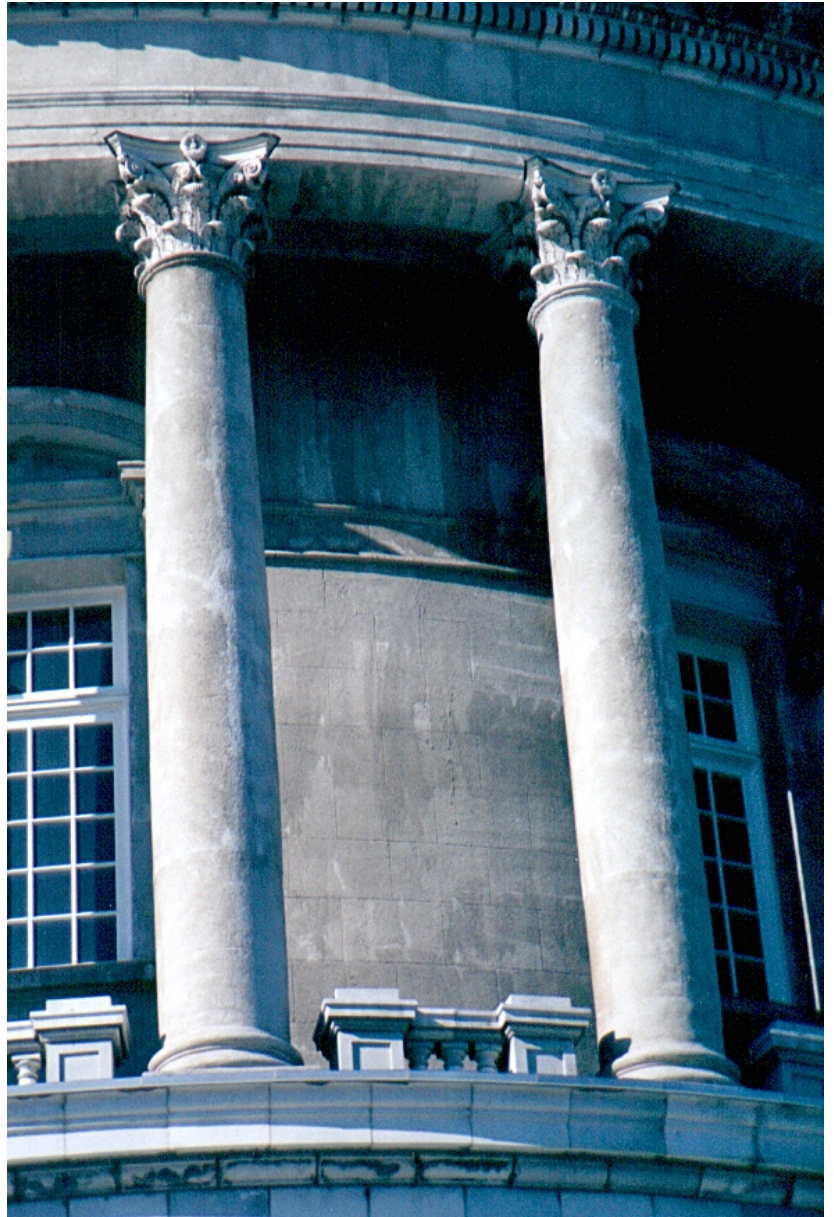
In addition to the stains associated with the patches and inclusions, there are stains of various colors, thicknesses and patterns on many other masonry surfaces. These are documented on our exterior materials survey forms.

To date, none of the stains, whether from patches and inclusions, or general surface staining, have been tested to determine their chemical characteristics and origins. Much of the gray surface staining is typical of the air-born pollutants found on the surfaces of other stone buildings in the city.

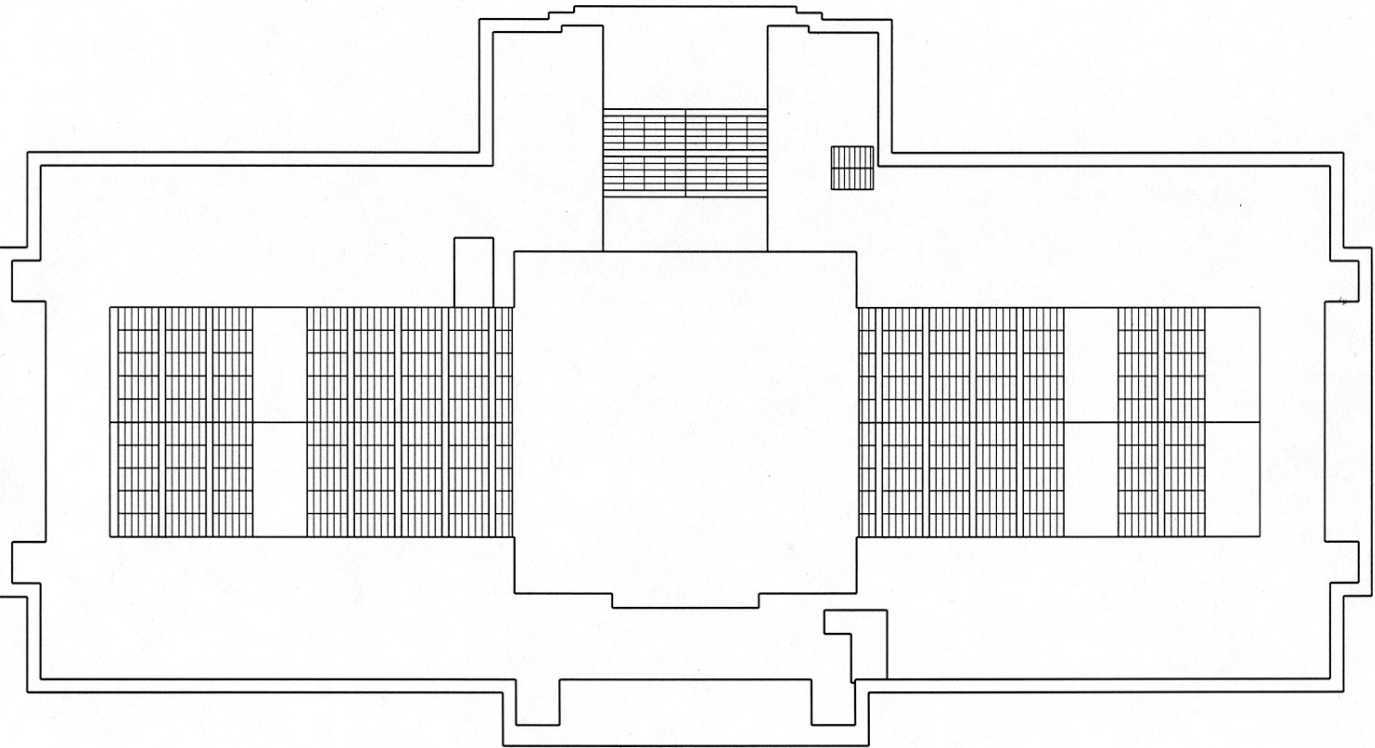
EXTERIOR SKYLIGHT PLAN

- c) Exterior Skylight System: The wired glass panels overlap one another with caulking at the seams to prevent water infiltration. The upper muntins and lower muntins then sandwich wired glass with
